Architectural Rehabilitation of Charasteen Cave in Duhok: A Locally-Led Accessibility and Heritage Intervention within the UNESCO–EU MADAD Framework with Support from the Kurdistan Regional Government

Mahmood Albrifkany

(Dr. Mahmood Albrifkany, Nawroz University/ Faculty of Engineering/ Architectural Engineering Department, Duhok, KRI, Iraq, mahmoud.muhammed@nawroz.edu.krd)

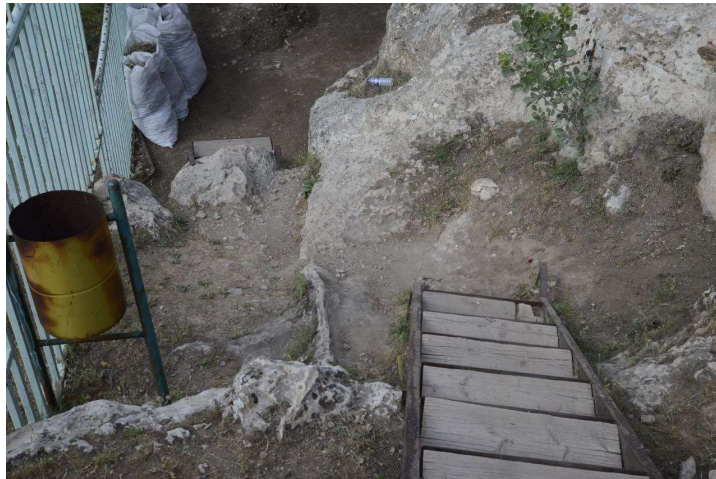
Prior to intervention, a full site assessment was conducted at Charsteen (Charsteen) Cave, and it revealed several challenges related to function, environment, and safety that impacted the site. One key issue was poor condition of pedestrian walkways and handrails which were broken or did not meet compliance requirements. Lighting within the cave was limited and improperly positioned, as shown in Figure 4. Drainage systems failed to address water stagnation which led to rapid erosion of the cave's surface.

Fig. 4: Pre-existing situation. Unsafe stairs, no stairs, deteriorated handrails, and bins on the west side of the Charsteen Cave.

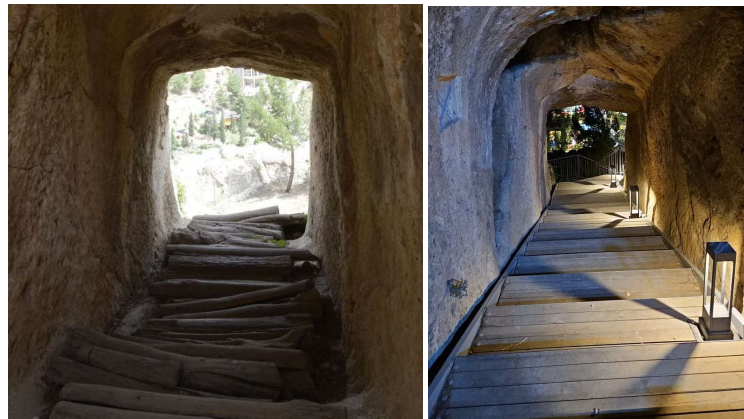
Steel works involved the design, manufacture and construction of handrail components, staircase and floor structural framing, benches, waste recycling containers, shade structures, stainless steel safety chain systems and signage systems (Fig. 8), that were constructed in compliance with regulatory requirements regarding both functional performance and safety, while visually being non-obtrusive. The wood works provided functionality and compatibility by installing stair treads, flooring, roofing and gabion-timber elements treated to ensure longevity under various environmental conditions and maintaining their natural appearance.

Fig. 8: Tunnel. The before and after intervention (iron and timber).

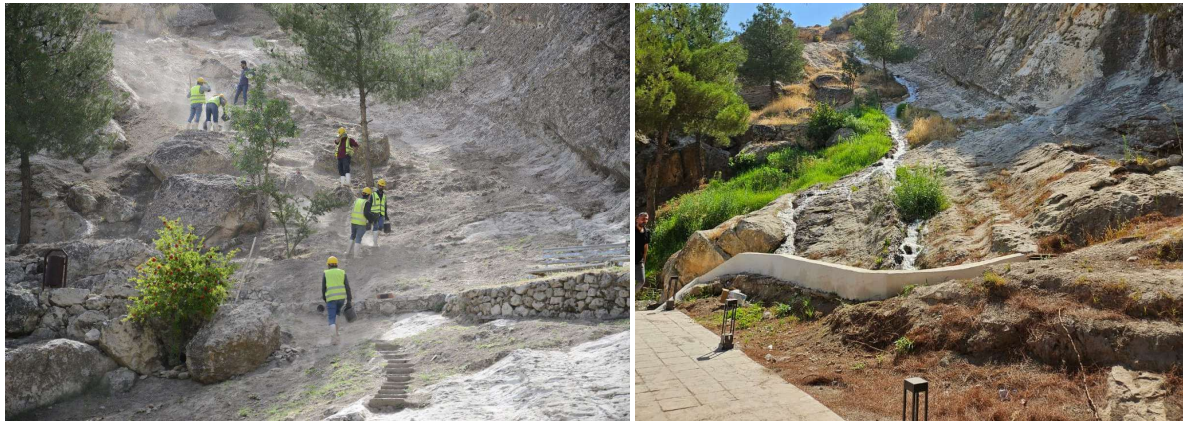
A water collection tank was developed to allow recycled water to be used from artificial waterfalls that had been relocated approximately 100-200 meters away from the cave to further minimize the effects of this aspect of the project, as shown in Figure 12. Ground cover, shrubs, and trees were planted as part of the landscaping aspects of the project. Signs in three languages (Kurdish, Arabic, and English) were also designed and installed as part of the project. All water, sewage, and electric systems were carefully routed away from archaeological areas with approval from Duhok DoAH Supervisors, and documentation was maintained to assist with future maintenance needs. Overall, the adaptive reuse projects at Charsteen Cave have extended the functional life span of the site while preserving its environmental and heritage attributes.

Fig. 12: artificial waterfalls that had been relocated approximately 100-200 meters away from the cave to further minimize the effects of this aspect on the entrance cave's surfaces (Before and After intervention).
