Mapping Park Maintenance Disparities Across Johannesburg's Socio-Economic Landscape: A Pilot Assessment Study

Abdulrasaq Ajadi Ishola, Trynos Gumbo, Tafadzwa Clementine Maramura

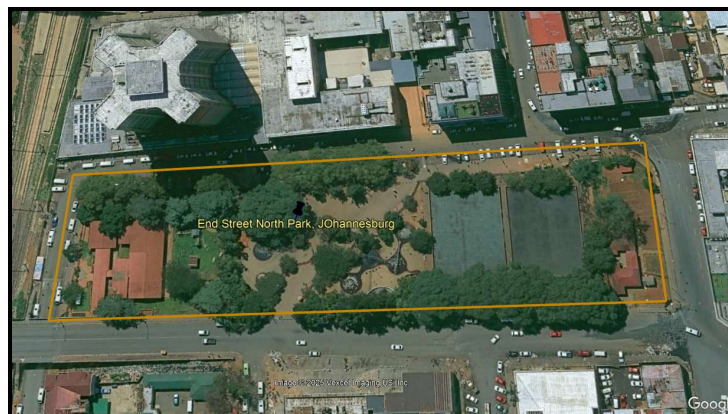
Figure 5: A close look at the End Street North Park.

This park is located at the centre of the city where residential and business buildings intersect, as shown in Figure 4. In the assessment of the park, it was found that the location of the park exposes it to encroachment from homeless people, who lodged around the perimeter of the park, despite it being well-fenced. Within the perimeter of the park, no significant infrastructure was noticed aside from the adjoining buildings that looked like municipal office buildings sharing space with the park; however, about four recreational facilities were seen, mainly for kids. Despite the encroachment, the park environment is well-maintained without any

visible graffiti or damage. This cleanliness is assumed to be due to the location of the park in the city centre, where its status can be easily noticed and thus poses a likely damage to the reputation of the city.
